MONITORING AND DEFORMATION ASPECTS OF LARGE CONCRETE FACE ROCKFILL DAMS

2   SHUIBUYA DAM

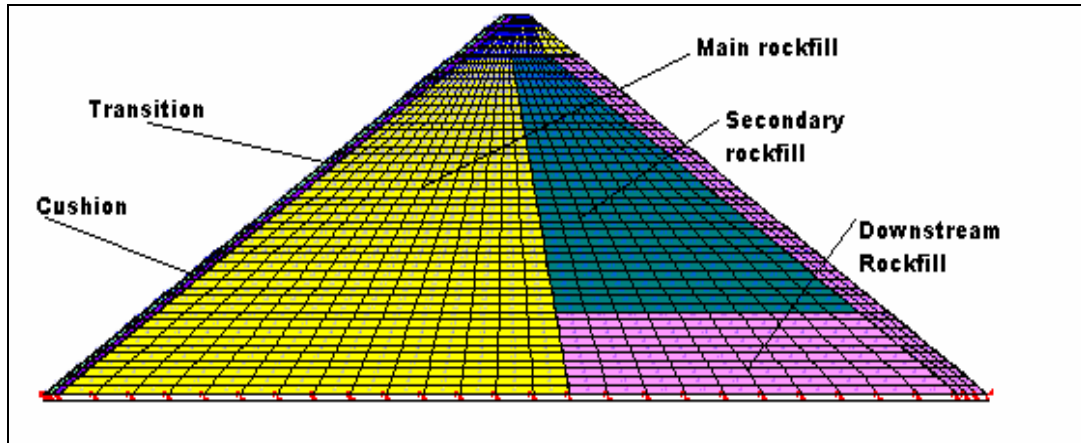
Figure 2: Shibuya Dam, FEM mesh and dam zoning.

The main and secondary rockfill zone of Shuibuya CFRD used the Maokou formation limestone and the mix of soft and hard limestone of Qixia formation. The dam zoning is shown in Fig. 2. The geotechnical parameters of the rockfill are given in Table 1 (Guo et al., (2004).

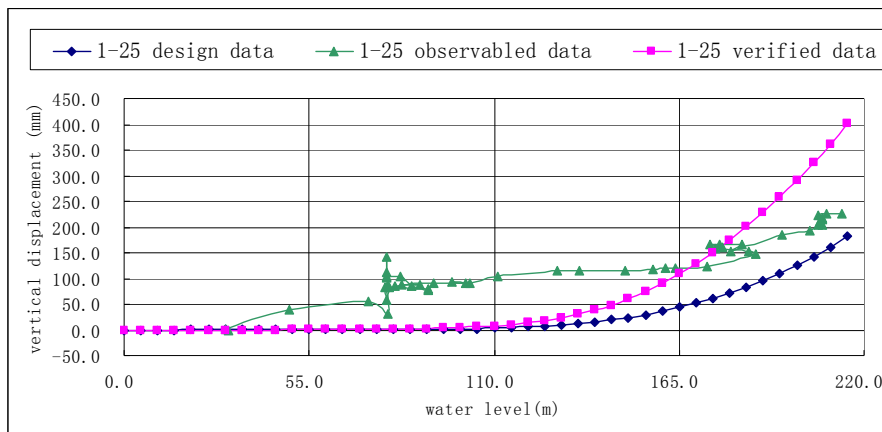
Figure 4: Location of the monitored points.

The geotechnical monitoring using interior wire extensometers to monitor interior displacement of the points located in the rockfill was started at the beginning of the filling up of the reservoir. The interior wire extensometer is shown on Fig. 3. The location of the monitored points is shown in Fig. 4. The measured settlements of point 25, point 29, and point 32 during the filling up the reservoir are given in Fig. 5, Fig. 6, and Fig.7 respectively.

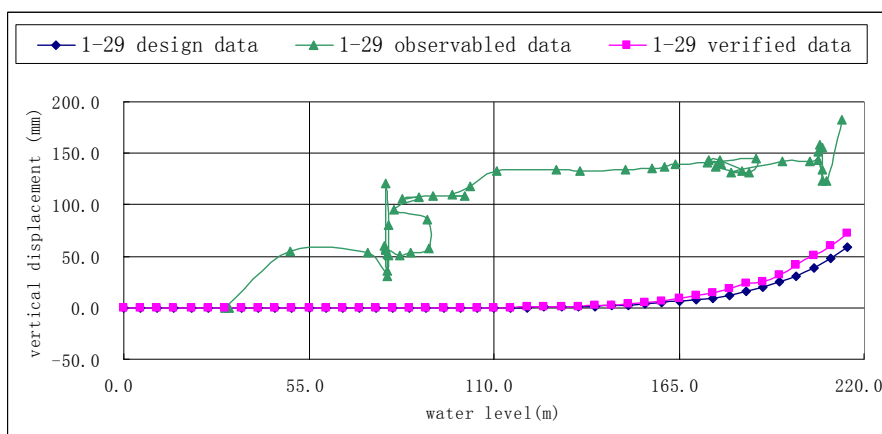
Figure 5: Settlement of pt 25.

The second FEM analysis was performed using calibrated geotechnical parameters of the rockfill. The parameters were based on parameters values of rockfill of Toulnustouc dam build in Canada (Massiera et al., 2005). The geotechnical parameters are given in Table 2. The maximum deformation of the concrete face at the end of filling of reservoir is 1.18 m (Fig. 4). The calculated settlements of point 25, point 29, and point 32 were larger than calculated at the design stage (Fig. 5, Fig 6, and Fig 7). The calculated deformations were closer to the measured values.

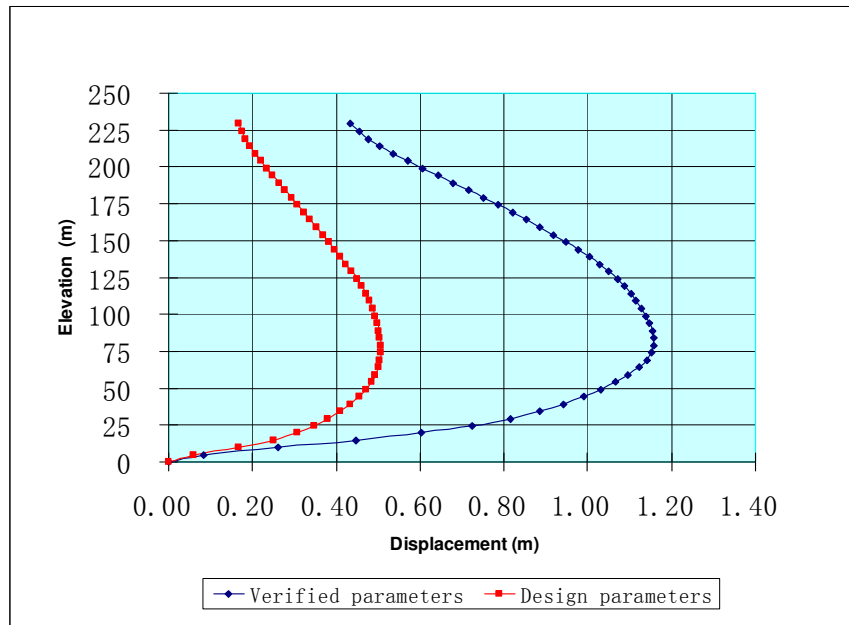
Figure 8: Calculated settlements (m) at the end of the filling of the reservoir for a CFRD

The first FEM analysis using the design geotechnical parameters gave the maximum value of the deformation of the concrete slab equal to 0.50 m. The calculated displacement is shown in Fig. 8. The result is in good agreement with the maximum values obtained by Guo et al., (2004) and Water Conservancy Project. The settlements of point 25, point 29, and point 32 were compared with the measured settlements. The calculated settlements were significantly smaller than measured (Fig.5, Fig. 6, and Fig.7). It indicated that the geotechnical parameters used in the prediction analysis did not agree with in-situ values.

In Fig. 8 the distribution of settlements of the concrete face using verified values of geotechnical parameters for different heights of water in reservoir are shown. On the same Fig. 8, the maximum settlement for the maximum water level using design geotechnical parameters, is shown. In the figure 8 it is shown that when the level of water in the reservoir

reached 150 m, than the maximum displacement of the dam modeled with verified geotechnical parameters was larger than maximum predicted displacement.

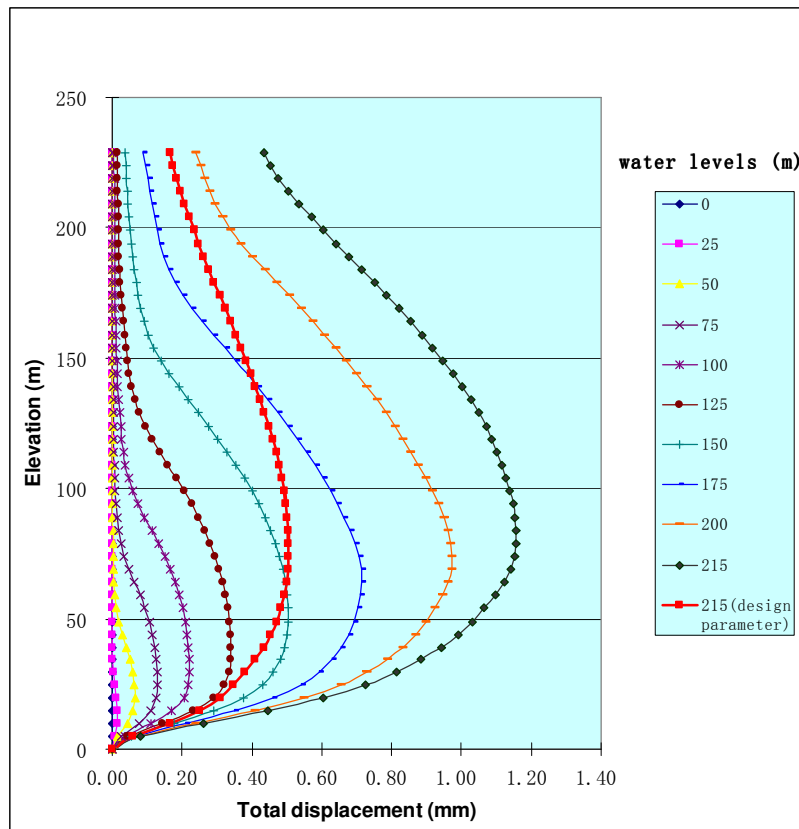
Figure 9: Total displacements (m) of the concrete face slab during the filling of the reservoir

The study shows that the in real time fusion of the monitoring results and FEM analysis would generate information that the deformations of the concrete face reached critical values before the reservoir level reached the maximum level. The fusion process of the monitoring results and FEM analysis should work in real time using data sets for measurements results

and FEM results interconnected using specific correlation criteria. The result of real time fusion would trigger the proper action from engineering team what would lead to prevention of the cracking of the concrete face.
